# SURFACE DECORATION OF STAINLESS STEEL FOR LBE FLOW MEASUREMENT BY ULTRASONIC TECHNIQUES

Kenji Kikuchi\*, Masao Tezuka\*\*, Shigeru Saito\*, Hiroyuki Oigawa\*, Yasushi Takeda\*\*\*

#### ABSTRACT

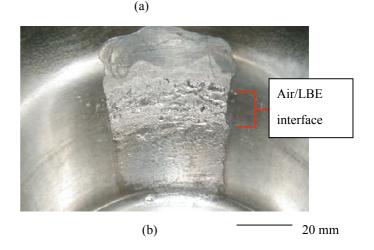
Fig. 2 Optical microscope of internal surface of the vessel (ID8). The vessel diameter is 8 cm. (a): Image before est, (b): Image after test.

Fig.2 shows the optical microscope images of the internal surface of the vessel (ID8) before and after 60 hrs exposures to the melting LBE. SnPb solver was coated partly in the vessel (a). Coated material still existed. Geometrical feature of coated area looks same in both images. The surface became rough, especially, at the interface of air and LBE. It should be noted that the echo intensity was high at the coated area but too low to detect at the uncoated area as experienced inID5. Uncoated area was not wetted by LBE.

At relatively low temperatures where the austenitic stainless steel is not corroded, ultrasonic method cannot be applied for measurement of LBF flow because the echo intensity will be too low to measure. However, the surface of the vessel is decorated by SnPb solver, this techniques will be applied. Question is why? Key issue is the wetting property between LBE and the vessel material. The wetting property is related to the surface energies at the contacting area ob LBE. If the steel surface is not wetted, the gaseous layer may exist between LBE and the steel where ultrasonic waves will not transmit to LBE because of the different impedance of the material. Although after the test (ID8) there was material remained on the wall as shown in Fig.2 (b) there was no evidence with regards to the wetting property in LBE.

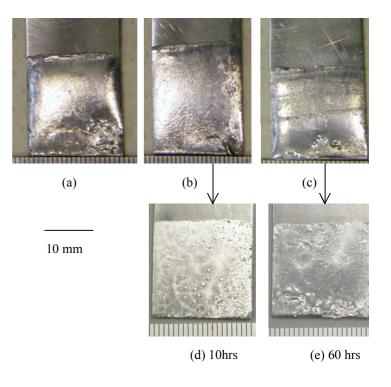
Fig.3 Submerged test of coated plates into LBE.

So we did test to examine a change of surface state of coated solver and LBE by submerging the reflector plates into LBE for sixty hours. Three plates made of SUS316 were prepared. One is a standard sample without any use in LBE. The other two specimens were submerged into LBE during 10 and 60 hrs, respectively. Fi.3 shows the optical microscope images of three plates. Figs.3 (a), (b) and (c) show the plates coated with the SnPb solver. SnPb solver was coated on the three plates in the same manner. Fig.3 (d) shows the plate (b) submerged into LBE during 10 hours. Fig 3(e) shows the plate (c) submerged into LBE during 60 hours. Surface morphologies of (d) and (e) look different from their originated images of (b) and (c), respectively. The cross sections of the plates were examined by the X-ray analyzer. It was found that Sn disappeared in the plates of (d) and (e) but Bi was detected in the remained materials on the plates as shown in Fig.4. The melting point of Sn Pb eutectic and LBE are 183°C and 124.5 °C, respectively. It is, however, thought that bismuth diffuses into coated SnPb and makes LBE in the solidified material on the plates. Optical microscope observation of the plate cross-section showed that thickness of coated layer was 500mm but reduced to 10 to 20 um after immersion in LBE. Fig.5 showed the photos of the cross section. The thickness of the coated materials on the plates was 500 mm. After immersion in LBE it reduced to 10mm by 60 hrs. Conclusively the coated material is so wetted that the supersonic sound can be transmitted at the interface of the steel and LBE.

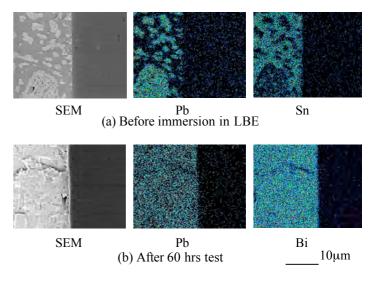
Fig.4 X-ray analyses of cross-section of coated SUS 316.

The ultrasonic wave property in the steeland LBE was examined at 140°C in air. SnPb solder makes possible to detect the sonic wave by enhancing wetting property of the steel. SnPb eutectic disappeared from the plate surface and PbBi eutectic covered the materials on the SUS316 plate. The thickness of the covered PbBi layer was 10 to  $20\mu m$ .
