In this study, the effect of spilling from neighboring sluice gates on stop-logs was experimentally investigated on a 1:65 physical scale model comprised of a double arch dam, a reservoir area, six spillway orifices and two stop-logs. Two types of measurement were performed: 2D velocity field in approach flow zone at the central horizontal plane of the orifices using two 0.5 MHz long range UVP transducers and dynamic pressures acting on the needle stop-logs at nine relevant positions using piezo-resistive pressure transmitter. The results showed that the pressure acting on the needle stop-logs followed hydrostatic distribution and velocity magnitudes in the zone of the needle stop-log are low and mostly unaffected by the spilling of the neighboring sluice gates.

?Ynk cfXg. Stop-logs, pressure, velocity field

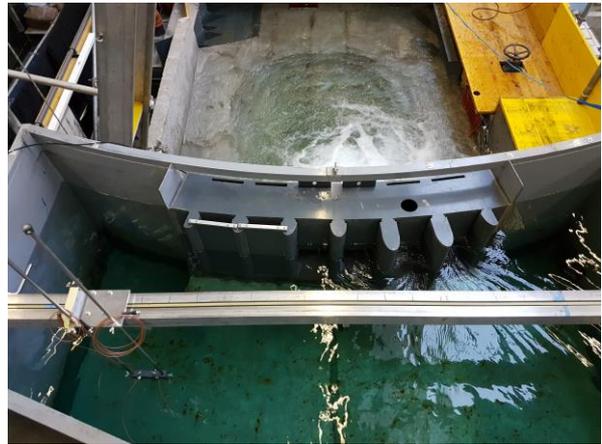
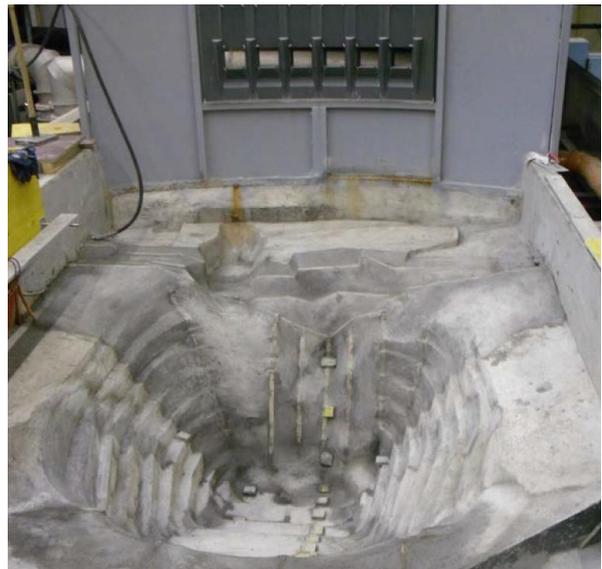
Figure 1. Physical model at LCH, view from upstream of Kariba dam orifice spillways with two stop-logs (top), view from downstream of the plunge pool towards the dam (bottom).

All experiments were carried out at the Laboratory of Hydraulic Constructions (LCH) of EPFL, Switzerland. The physical model (Figure 1) consists of a reservoir area of 190 m by 220 m horizontally and of 100 m vertically, the Kariba dam with its crest and complete set of spillway sluices (six), the free falling jets, the complete plunge pool and the tailwater zone with two power house outlets. The physical model is constructed with geometrical scale factor of 1:65 and the model is operated following Froude similitude and therefore the maximum discharge for the entire spillway of 9'000 m³/s in prototype corresponds to 264 l/s in the model. Needle stop-logs were manufactured

using 10 mm thick PVC plates with variable dimensions corresponding to the appropriate sluice and the stop-logs were placed and sealed to gates (Figure 1).

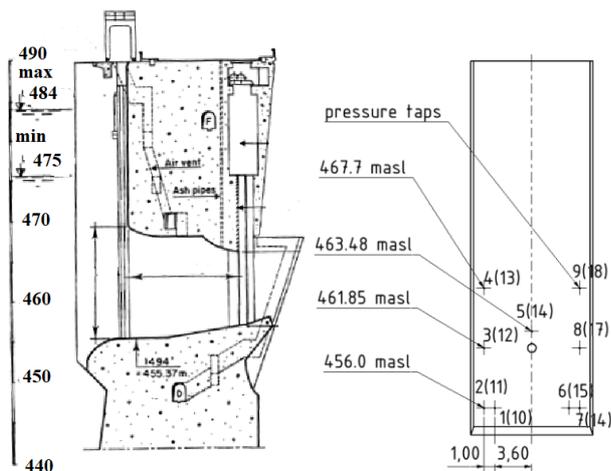
Figure 2. Sluice gate cross-section (left) and pressure taps position and designation-values in brackets correspond to second stop-log plate (right).

Each of the stop-log is equipped with 9 pressure taps (Figure 2), 15 mm long with 8 mm diameter which are pierced with a 2 mm micro tube. On each pressure tap, tubes with inner diameter of 8 mm were placed and connected to a multiplexer. The outlet tube of a multiplexer was connected to a piezo-resistive pressure transmitter for dynamic pressure measurement. The piezo-resistive pressure transmitter is of flush diaphragm type (Baumer, Switzerland) with an acquisition range between +/- 0.1 bar with an accuracy of +/- 0.001 bar. Pressures were collected at a sampling rate of 1 kHz for 66 s. The transmitter was calibrated before pressure measurements and the tubes were purged before each measurement.

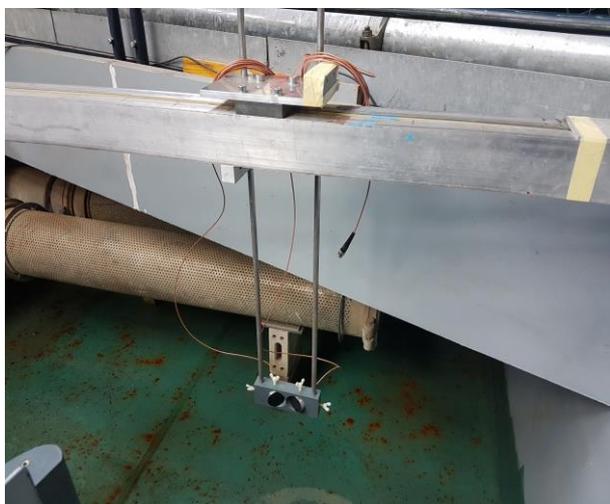
Figure 3 UVP sensors, frame and carriage

Velocity measurements were performed using a non-intrusive Ultrasound Doppler Velocity Profiler (Metflow, Switzerland). 2D velocities were recorded in the approach zone of the dam covering an area of 33.8 m by 156.0 m using two 0.5 MHz long range transducers with active diameter of 40 mm.(Figure 3). The transducers were placed horizontally in a frame (Figure 3) so that the beam axis formed a mutual angle of 60°.

The vertical position of the transducers axis was kept constant at the centre axis of the sluice opening corresponding to 462.3 meters above sea level (masl). The frame, which was attached to a carriage (Figure 3), was moved in 49 positions transversally across the width of the reservoir (with a step of 3.25 m) in which velocity profiles were recorded. The position of the carriage was measured with Leica D150 laser distometer with an accuracy of +/-1 mm. In such a way, a diamond shaped grid presented in Figure 4 is formed. In each intersection recorded velocity components were extracted from the corresponding velocity profiles giving 2D velocity components.

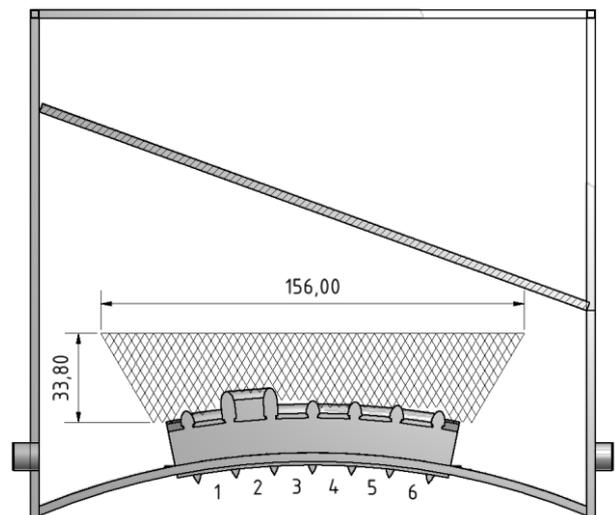
Figure 4 Velocity measurement grid and sluice gate designation

The physical model tests were conducted with two gates closed using stop-logs. In total three configurations were investigated: 1) Sluice no. 5 and 6 closed with stop-logs; 2) Sluices no. 3 and 4 closed with stop-logs; 3) Sluices no. 1 and 2 closed with stop-logs (see Figure 4). Herein only the second configuration will be presented since other configurations yield similar results. For each configuration, four different scenarios were tested, in

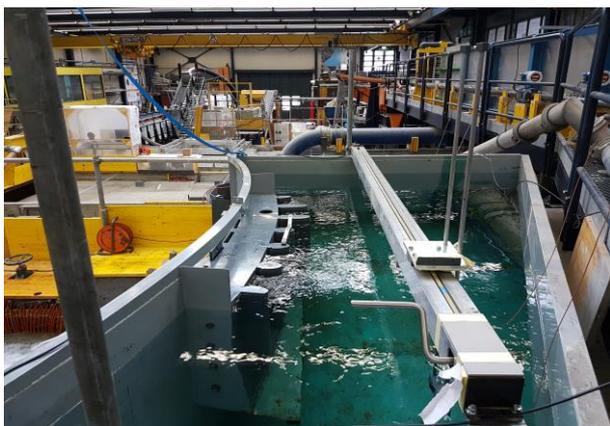
Figure 5. Model in operation for scenario IV at 488.5 masl, view of the approaching zone from the right side.

Up-scaled mean pressures P_{mean} , standard deviation σ and corresponding hydrostatic pressures P_{HS} for scenario IV at water level 488.5 masl for 18 pressure points (pressure taps 1-9 correspond to stop log at gate No. 3 and 10-18 at No. 4) are given in Table 2. Since results for other configurations and scenarios yield similar results and due to space limitation they are not presented herein. For all tested scenarios and water levels time averaged pressures on stop logs follow hydrostatic pressure distribution (Table 2). Standard deviations of pressure readings for all tested scenarios and water levels are below 0.15 m WC and are less than 1% of water depth. These results were supported with visual observation made during the tests. In the zone of the stop-logs, water surface is smooth, horizontal and undisturbed by the spilling of adjacent sluices (Figure 5 and 6). No negative pressure has been observed in the physical model.

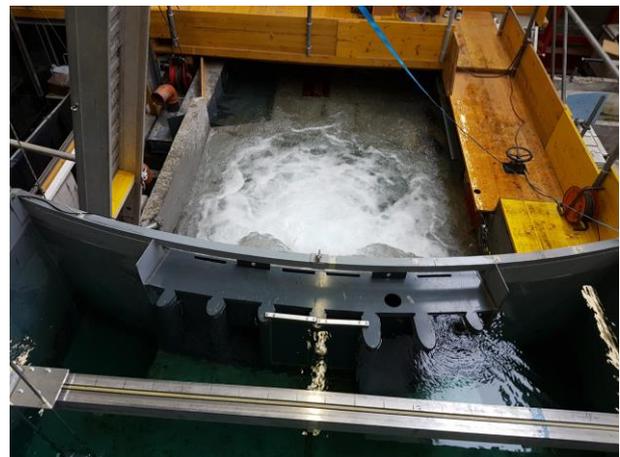
Figure 6 Model in operation for scenario IV at 488.5 masl, top view of the approaching zone.

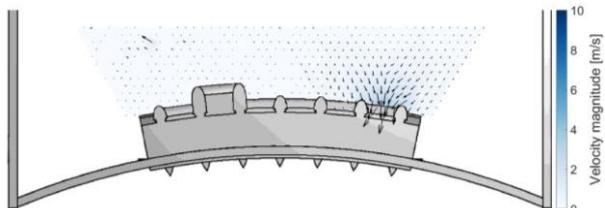
Figure 7 Time averaged velocity field in approaching zone of the dam for scenario I at 475.5 masl

Time averaged velocity vector plot superimposed on velocity contour line plot of time averaged velocity field in the approaching zone of the dam for scenarios I-IV at 475.5 masl and for scenario IV at 482.0 and 488.5 masl are given in Figures 7-12.

Time averaged velocity magnitudes increase with the increase of water level as well as with the increase of the number of opened sluices. Velocity magnitudes in the zone of the opened sluices can reach up to 10 m/s. In the zone of the stop-logs time averaged velocity magnitude for scenarios No. I and II are below 2 m/s whereas for scenario III and IV they may reach up to 4.5 m/s (in the

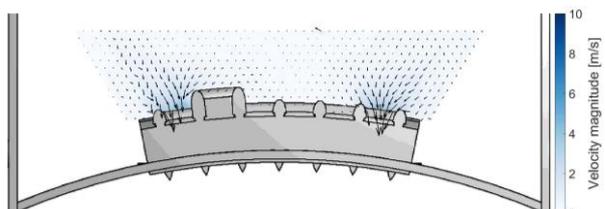
Figure 8 Time averaged velocity field in approaching zone of the dam for scenario II at 475.5 masl

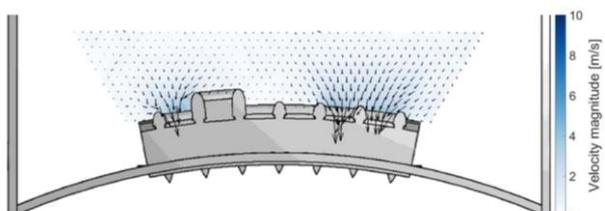
Figure 9 Time averaged velocity field in approaching zone of the dam for scenario III at 475.5 masl

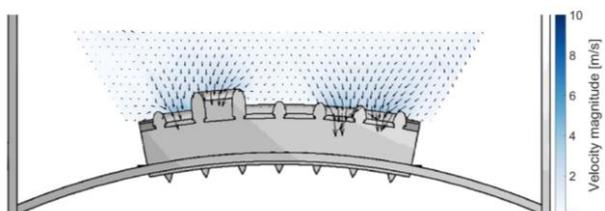
Figure 10 Time averaged velocity field in approaching zone of the dam for scenario IV at 475.5 masl

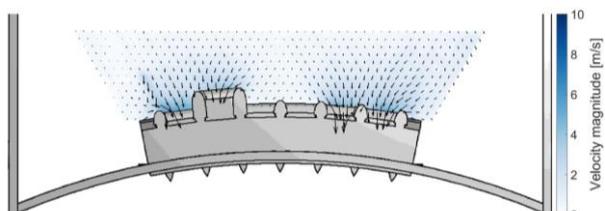
Figure 11 Time averaged velocity field in approaching zone of the dam for scenario IV at 482.0 masl (Table 1.).

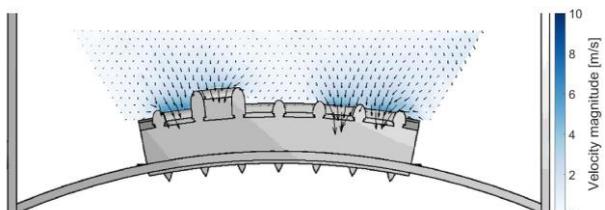
Figure 12 Time averaged velocity field in approaching zone of the dam for scenario IV at 488.5 masl

It can be noticed that mean velocity magnitude are low and mostly unaffected by the spilling of adjacent sluices. This observation is in agreement with visual observations and pressures measurements on the stop-log. Based on the above presented measurements it can be concluded that, for the tested conditions, stop-logs are very limited affected by the spilling effects of neighboring sluices.
